Case Studies

Location Reedy Creek, Gold Coast Qld.

Type of wall constructed – “B Grade cut” Sandstone boulder

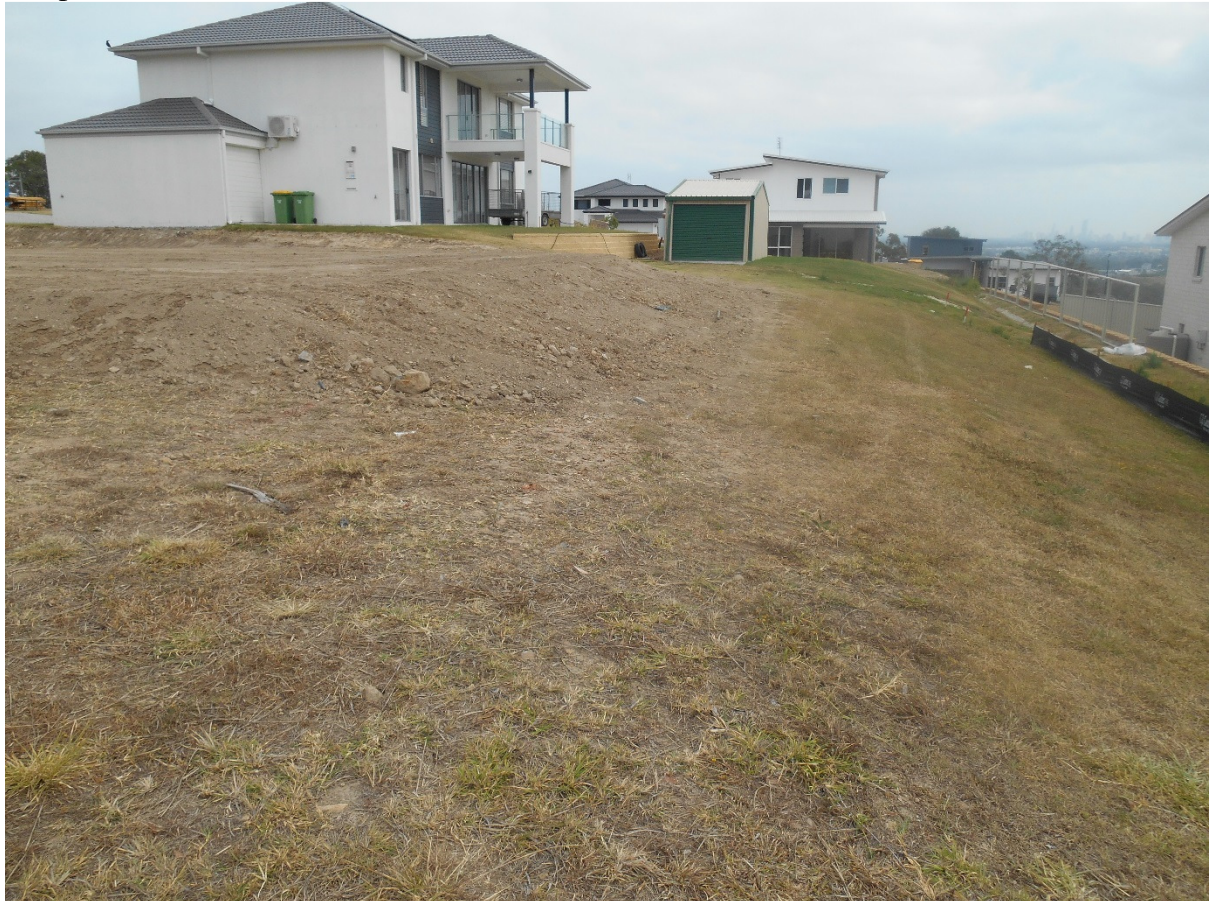
A large site requires a large retaining wall! Australian Retaining Walls were recruited for this “B Grade cut” Sandstone boulder wall in Reedy Creek, Gold Coast Qld. Because of the size of the Sandstone boulders required for this project and the impending construction of the house our client needed a quality job done quickly....Not a problem for Australian Retaining Walls! As soon as the pool was built Australian Retaining Walls arrived to commence construction of this “B Grade cut” Sandstone boulder wall in Reedy Creek, Gold Coast Qld.

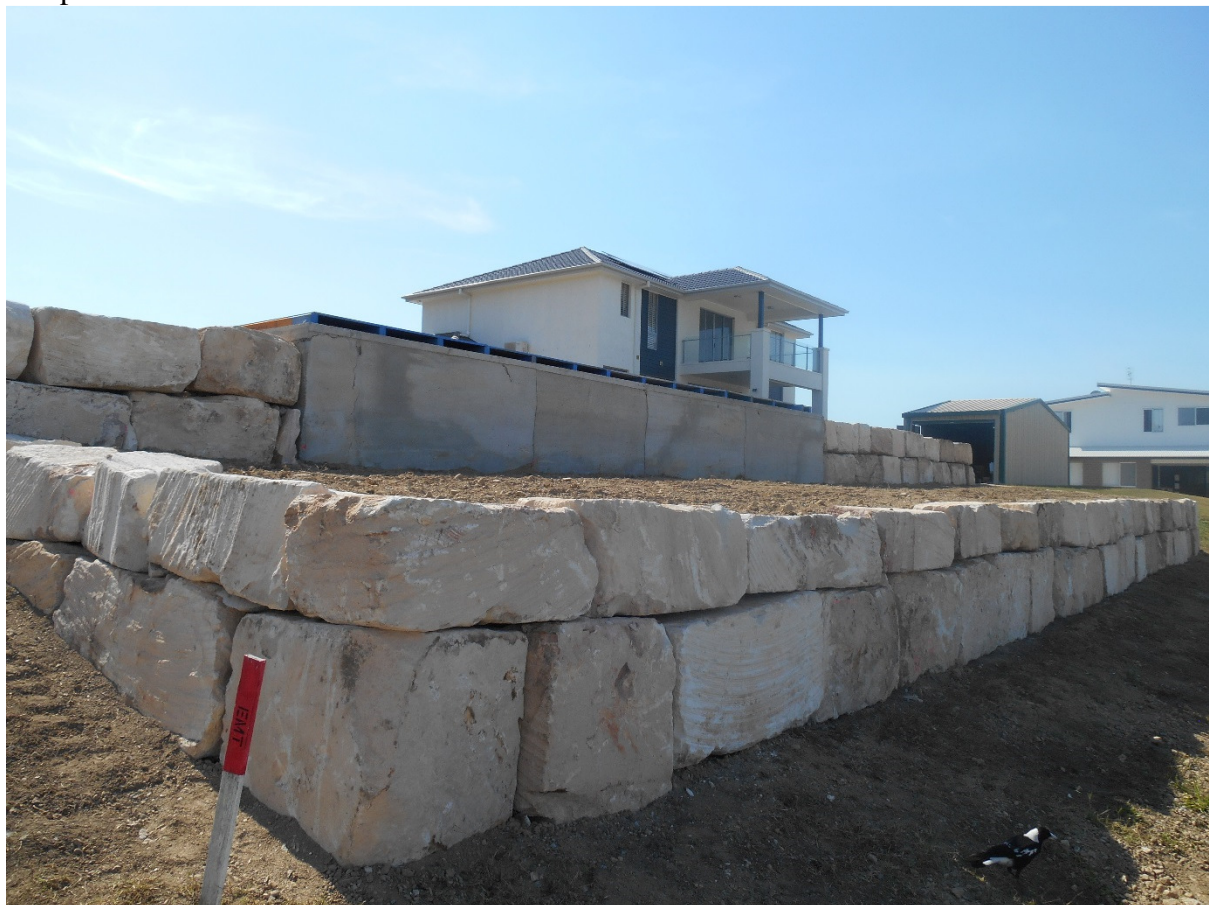
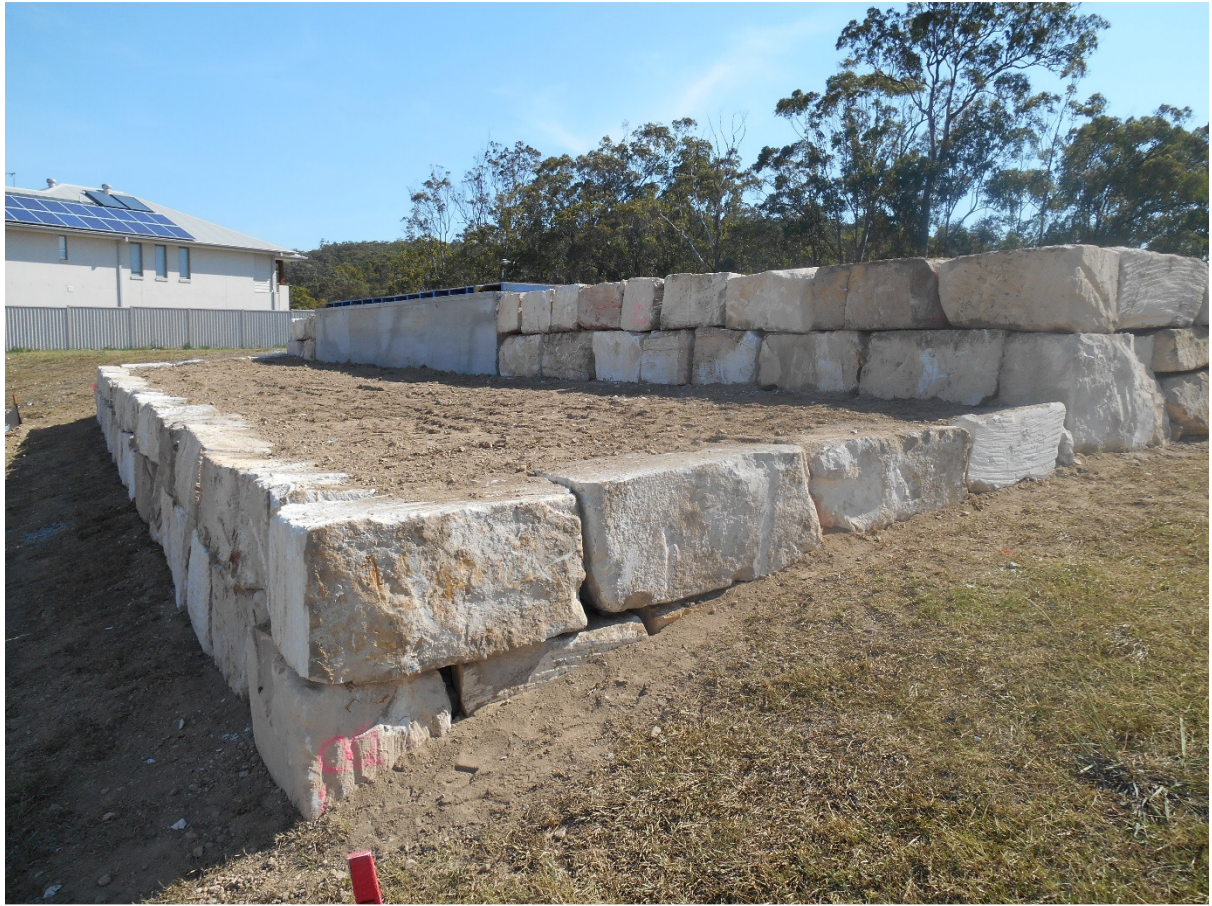
As this plot falls quite quickly away. A two tier “B Grade cut” Sandstone boulder wall was decided to be the best option for this property in Reedy Creek, Gold Coast Qld. The two tier option allowed our client to obtain two large flat areas instead of the one largely unusable sloping area that they previously had. The top tier creates a great flat area next to the pool and there is plenty room on the middle tier for turf or a large garden.

Another “B Grade cut” Sandstone boulder wall project completed successfully and on time for Australian Retaining Walls!
