Case Studies

Location Southport, Gold Coast Qld.

Type of wall constructed – Windsor concrete blocks.

Brief description of work completed.

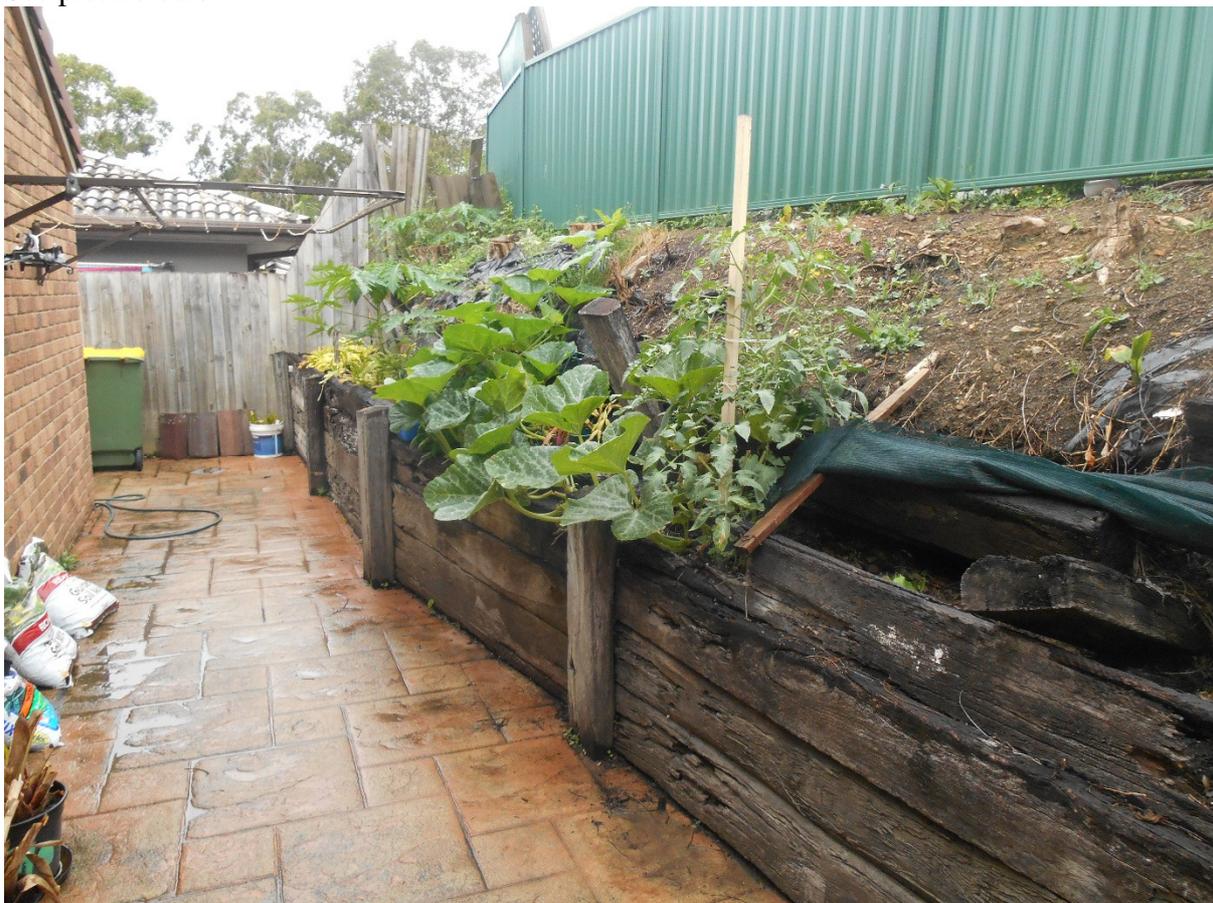
Australian retaining walls arrived at this residential Southport, Gold Coast Qld address to find this failed timber retaining wall in desperate need of attention. The top tier as you can see was virtually non-existent and the bottom tier was hanging on for dear life! A Windsor concrete blocks wall was deemed to be the perfect solution as it is a relatively small block and two tiers had to be accommodated in this tight space. Building two tiers can be an option if you need to retain an area larger than 1 metre. Council permission is required on walls over 1 metre and this can be a good way to keep costs down.

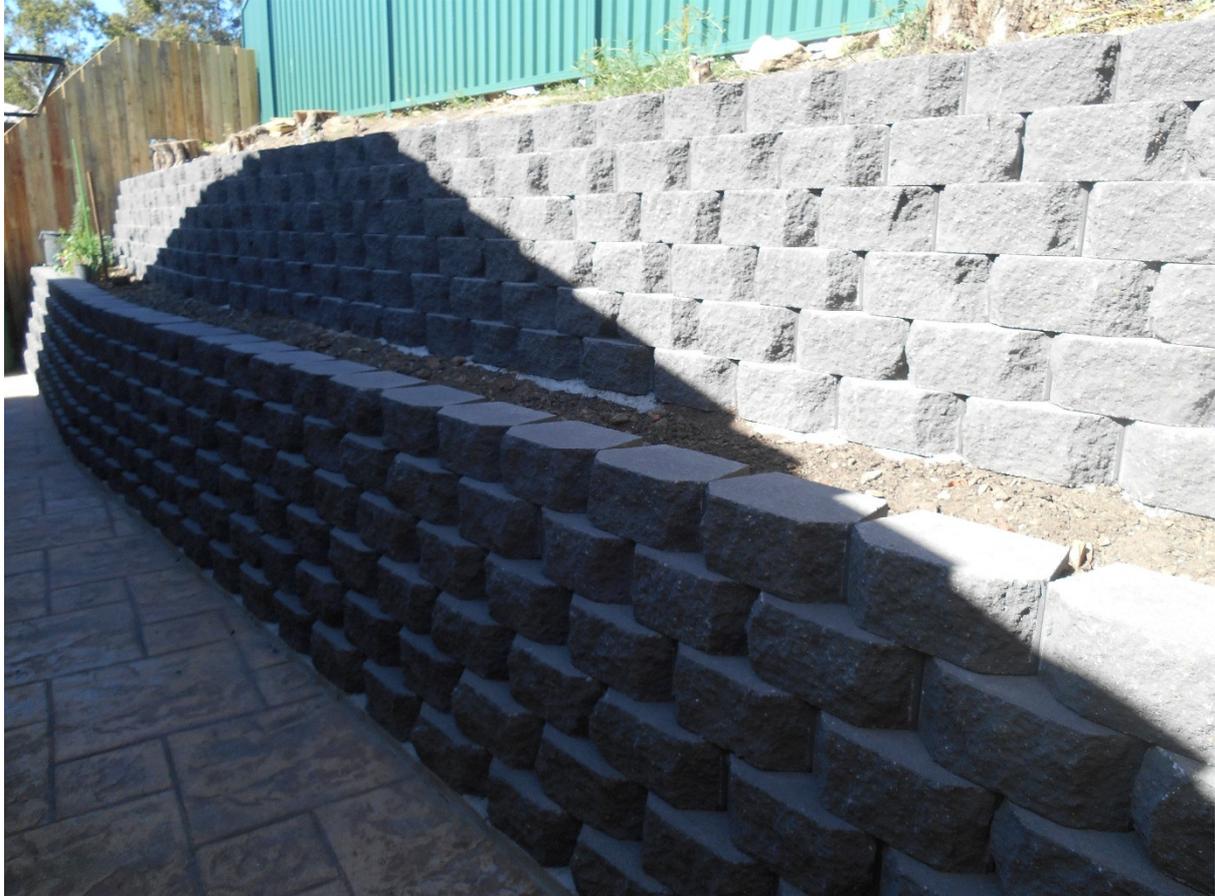
The threat of damage to the printed concrete and limited access meant an excavator was not considered for this Australian Retaining Walls project in Southport, Gold Coast Qld.

Demolition and preparation commenced the old fashioned way and the old wall was torn down and disposed of. Excess soil was removed and the tiers were shaped before digging a footing. Only the top tier would require a footing dug out as the bottom tier would be laid (on a bed of mortar) directly on to the printed concrete.

The bottom tier was built first by Australian Retaining Walls, the base blocks set in cement and the rest stacked on top with 20mm gravel and a 65mm pipe installed for drainage, Geotextile fabric is pinned to the bank to prevent soil particles from blocking the pipe. The process is repeated for the top tier except the blocks are laid on concrete base.
