Case Studies

Location Upper Coomera, Gold Coast Qld.

Type of wall constructed – Vertica concrete blocks with nofines concrete reinforcing.

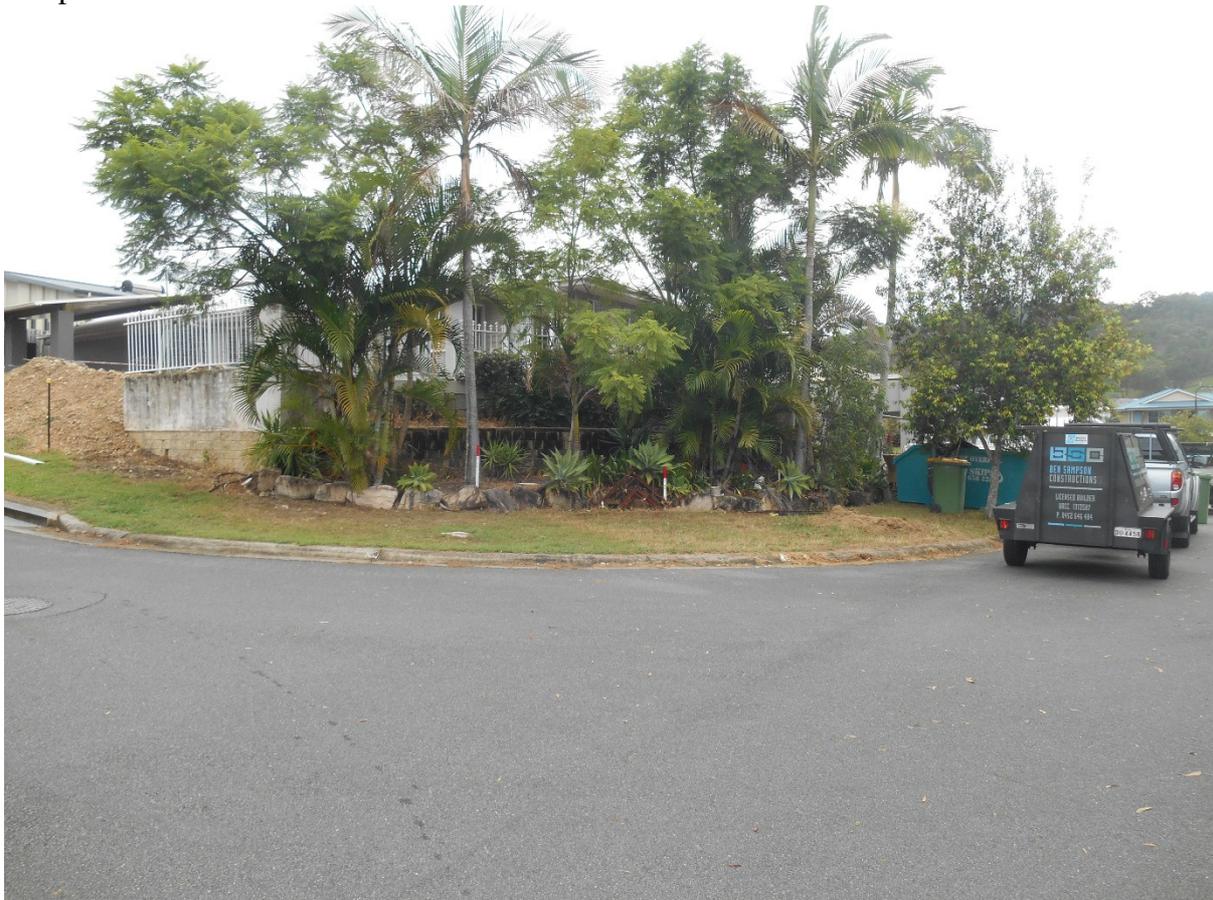
Australian Retaining Walls were called in to assist with the design and help choose the most suitable system for this 2.1 metre high wall in Upper Coomera, Gold Coast Qld. After careful consideration a Vertica concrete block with nofines concrete reinforcing was deemed the best option for this site. As this wall would be over 1 metre tall, council permission had to be obtained and engineer plans drawn up and submitted. After the necessary permits were obtained a date was set and Australian Retaining Walls could commence construction.

See picture below.

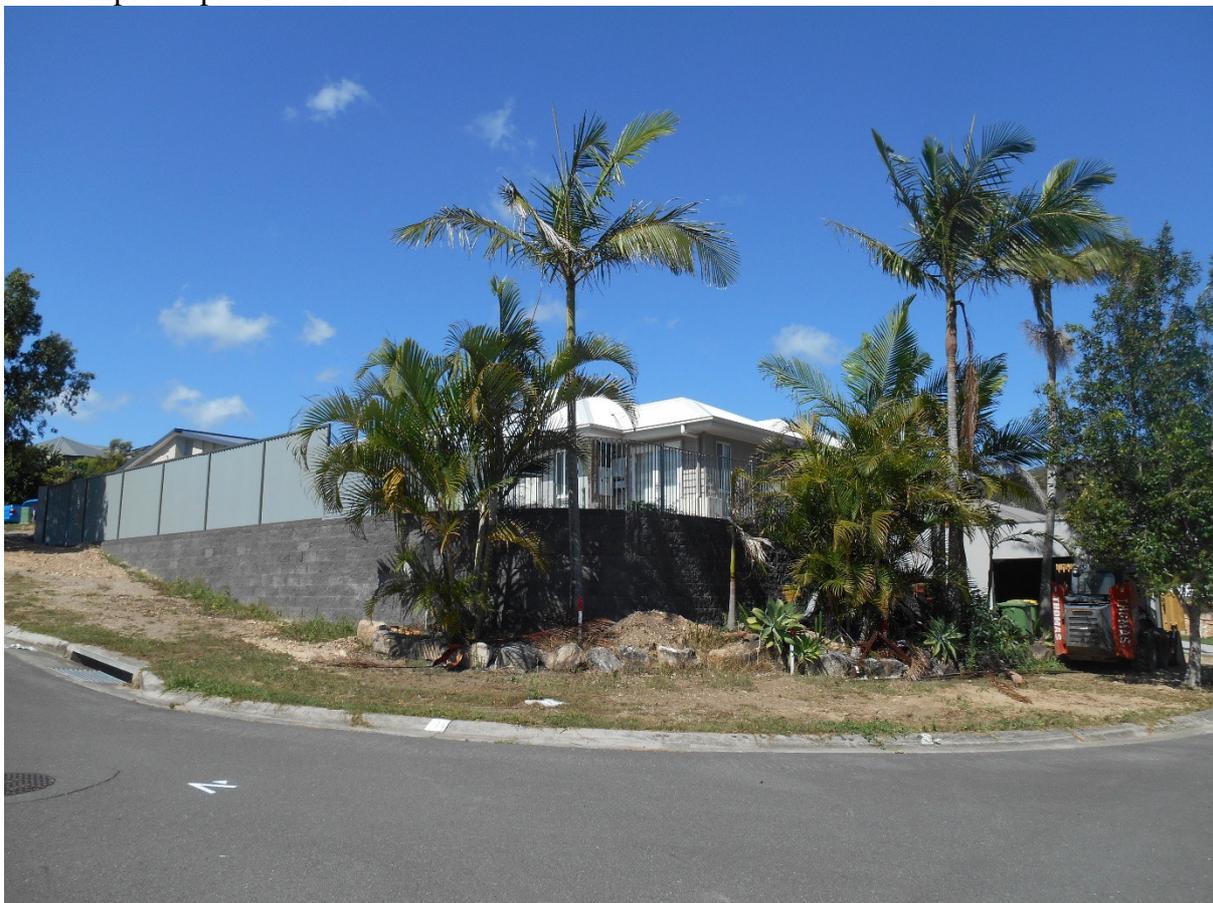
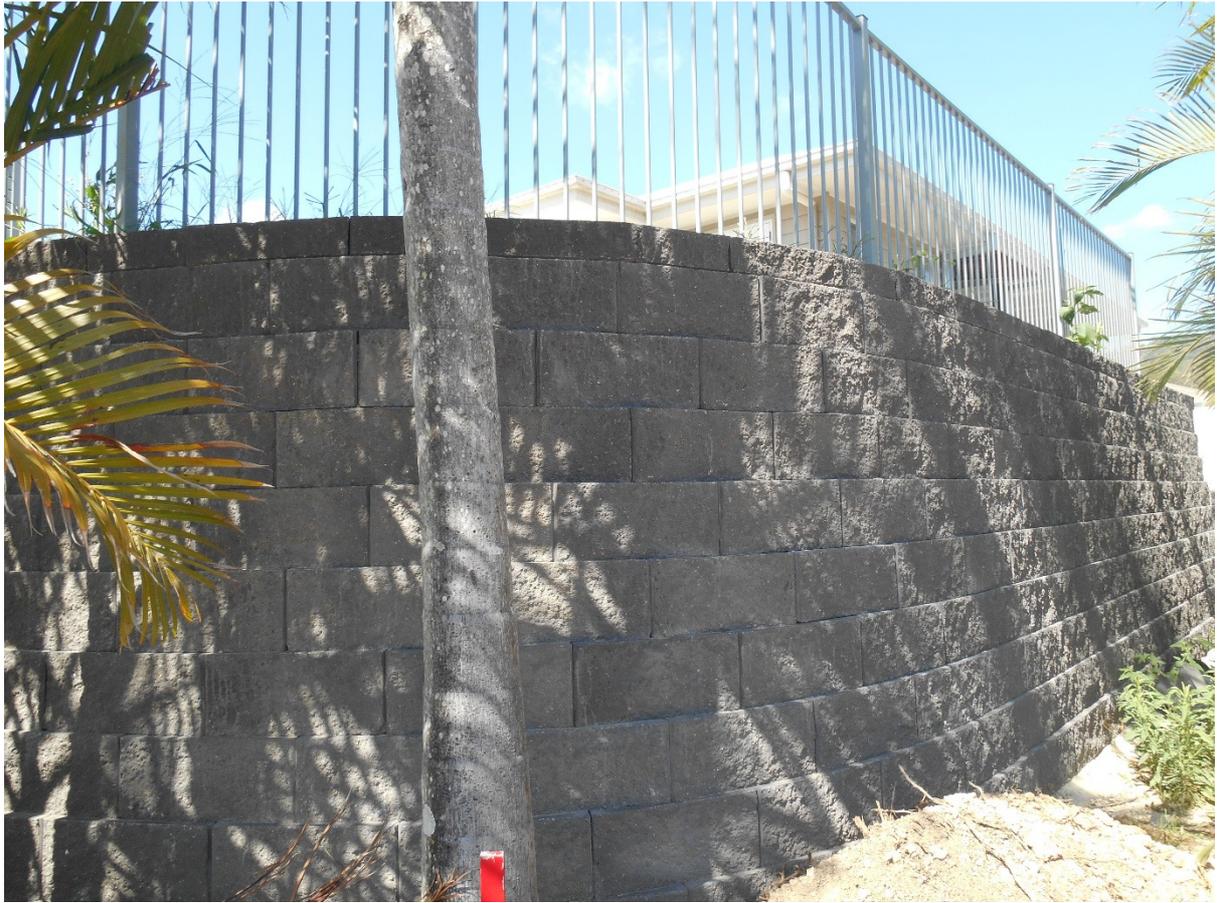
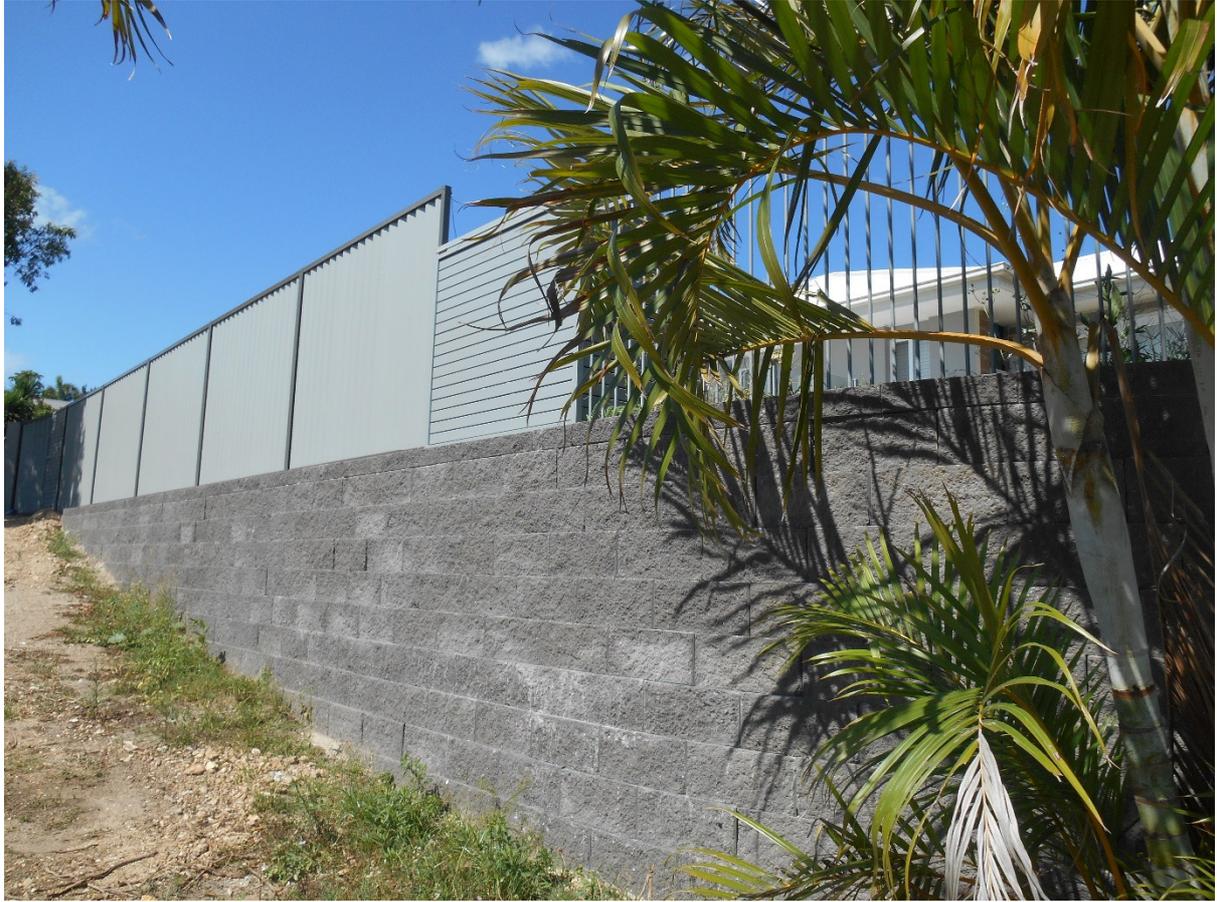
Once demolition was complete the guys at Australian Retaining Walls could commence construction of this Vertica concrete blocks with nofines concrete reinforcing. Lines, heights and levels were determined and the base blocks were set in concrete. The existing bank was then covered in geotextile fabric before the nofines concrete reinforcing was pumped behind the wall and the rest of the blocks stacked to the desired height, in this case the final height was determined by the newly installed pool.

See completed pictures below –
